Punjab Municipal Development Fund Company

Hiring of Consulting Services for Preparation of Integrated Development and Asset Management Plan (IDAMP) for 16 selected MCs In Punjab under Punjab Cities Program (PCP)

> IDAMP - Municipal Committee Jaranwala May 2023

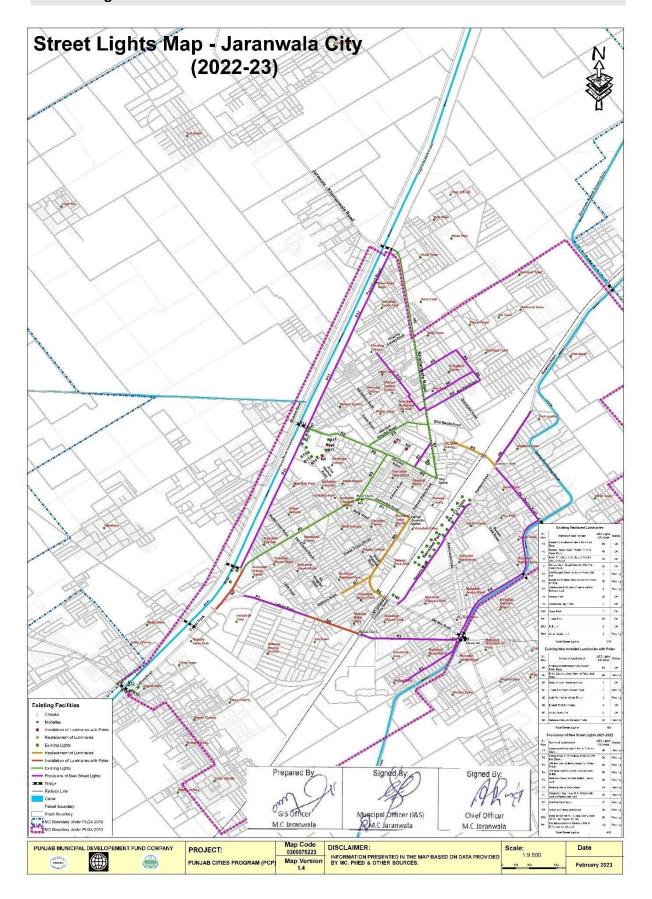
### 7. Street Lights

Detail Of Street Light (F	ully Serveyed Meter)	
		Streetlights	MC Operated	Privately operated
Operational Lights	Street	46	46	0
Non-Operational Lights	Street	268	268	0
Total		314	314	0
		Detail Of Street Light (Pa	rtially Serveyed Meter)	
		Streetlights	MC Operated	Privately operated
Operational Lights	Street	43	43	0
Non-Operational Lights	Street	234	234	0
Total		277	277	0

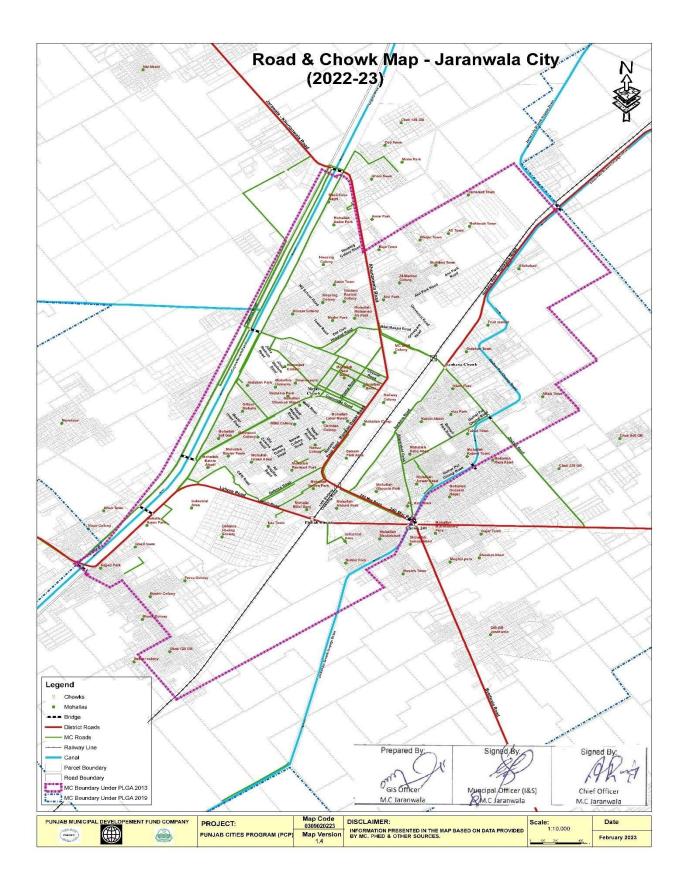
#### 8. Roads

Sr.	Road I	Name	TST, Asphalt Or Concrete Pavers	Row (Ft)	Paved Width (Ft)	Approx.
	From	То		· -7		(KM)
1	Pakistani Gate via Rail Bazar	Circular road	Asphalt	40	40	0.457
2	Abdullah Park road	Canal road	Asphalt	20	15	0.600
3	Bohranwala Chowk	Kothi Ghulam Rassol	Asphalt	20	20	1.000
4	Milad Chowk	Market Committee	Asphalt	110	35	0.610
5	Market Committee	Ramzan Bazar	Asphalt	65	25	0.457
6	Ramzan Bazar	Water works	Asphalt	65	25	1.280
7	Market Committee	240 More	Asphalt	50	30	1.768
8	240 More	Gulhar Pull chungi	Asphalt	40	25	0.366
9	Jhumra road	Gulhar road up to Municipal limits	Asphalt	40	30	1.234
10	Bilal Masjid	Canal via Kothi Ghulam Rasool	Asphalt	30	20	1.000
11	Benazir Park	Saim nala via Kabeer Chowk	Asphalt	40	30	0.823
12	Railway Station Chowk	Phatak Lahore road	Asphalt	50	15	0.457
13	Garden hotel (Masjid Bazar)	Cinema Chowk	Asphalt	30	30	0.457
14	Malik House	Lahore road -Nazir Bhatti	Asphalt	20	20	0.762
15	Old Civil Hospital	Sabri Masjid Chowk	Asphalt	50	25	0.671
